# Hemi-pelvectomy Amputation

**Stuart Crampton**

**St Vincent's Health Melbourne**

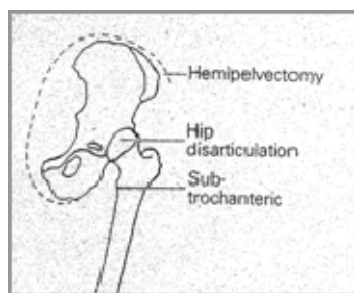
**Figure 1.** Amputation levels around the Pelvis

Amputations around the Pelvis have always posed a significant challenge for the Rehabilitation team and indeed the patient. Over the years the descriptions of these levels have changed, historically the Hindquarter amputation described the removal of the entire lower limb and half of the Pelvis. Today the terms Hemipelvectomy (HP), Transpelvic (TP) and Hip disarticulation (HD) are more commonly used. The HP amputation is the modern term that describes amputation of the entire hemipelvis and limb as did Hindquarter previously. Figure 1. shows the accepted descriptions.
